Garvoc Fire (The Sisters) 17 March 2018

Technical investigation report

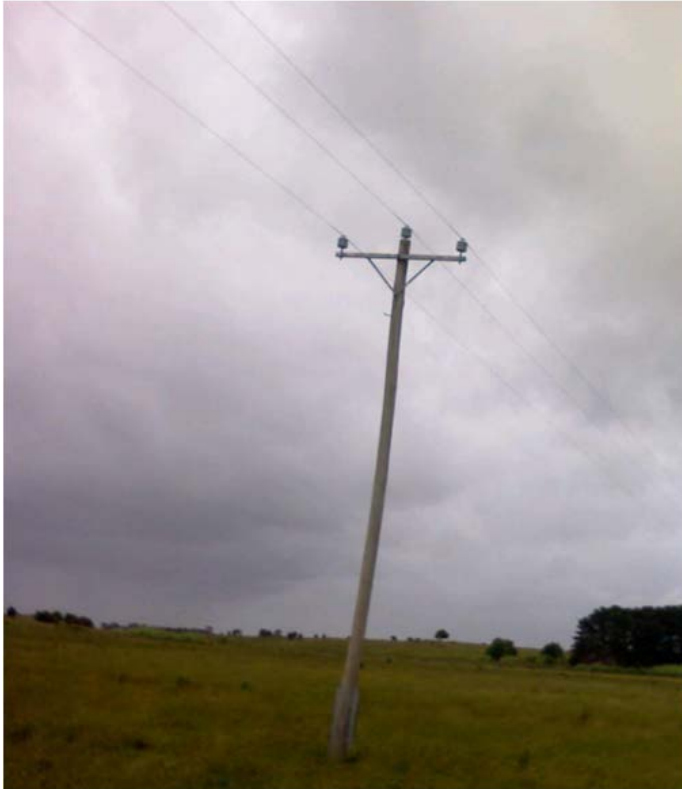
Figure 1: Pole 4 prior to failure (taken 5 December 2012)

- supporting three galvanised steel conductors each made up of three strands of 2.75 millimetre diameter galvanised steel
- leaning 1.2 metres perpendicular to the line route (a column eccentricity of 1.2 metres with respect to the point of failure) on 5 December 2012 as per Figure 1

A visual assessment of the photograph of the pole before it failed showed three overhead conductors (with other evidence indicating that each conductor comprised 3 strands of 2.75 millimetre wire). It also showed there was a lean of 1.2 metres (a column eccentricity of 1.2 metres with respect to the point of failure).

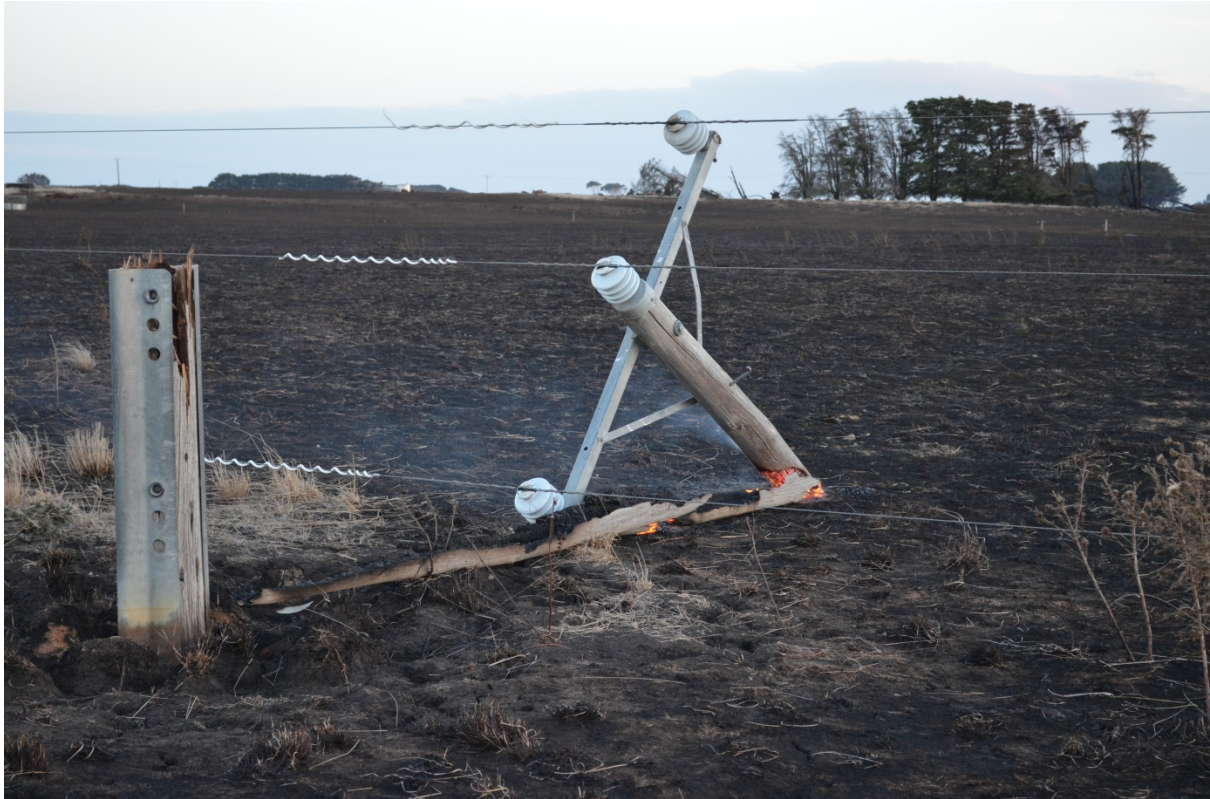
Figure 7: failed Pole 4, 974 Sisters-Garvoc Road

Figure 7 shows an image of Pole 4, which was found to have structurally failed at the top of the pole stakes/steel reinforcement. The photograph shows the:

- remaining pole butt and the upper section, which snapped at the top of the steel RFD 600X2 reinforcing stakes; the stakes/steel reinforcement did not fail
- conductor closest to the ground is in contact with the pole and the ground
- extent of burned grass and vegetation around the failed pole
- armour rods and vibration dampers installed on all three conductor phases.

The engineering analysis concluded that the structural failure of Pole 4 was caused by long-term material degradation due to decay and termite infestation, while its 1.2 metre lean was a contributing factor. The long-term material degradation resulted in the timber's reduced compressive and flexural/bending strength, development of a sizeable internal cavity in the region of the point of failure, and the reduced overall capacity that saw the pole's design strength exceeded under the prevailing wind conditions on the day.

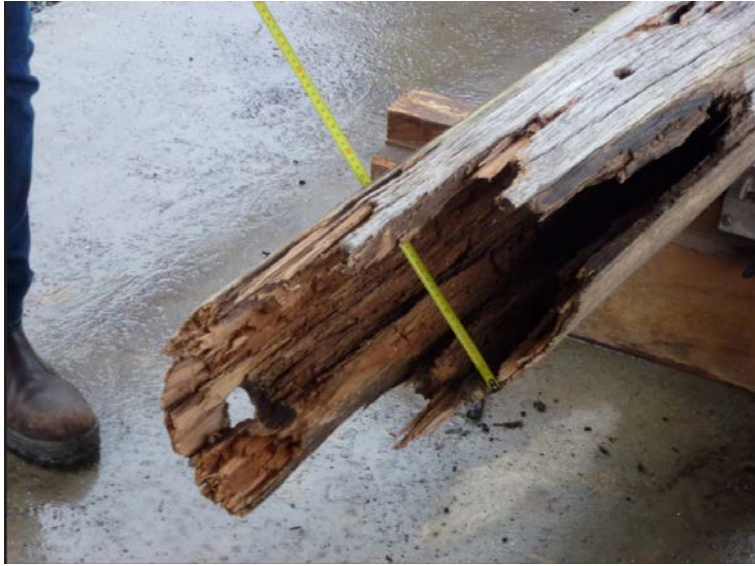
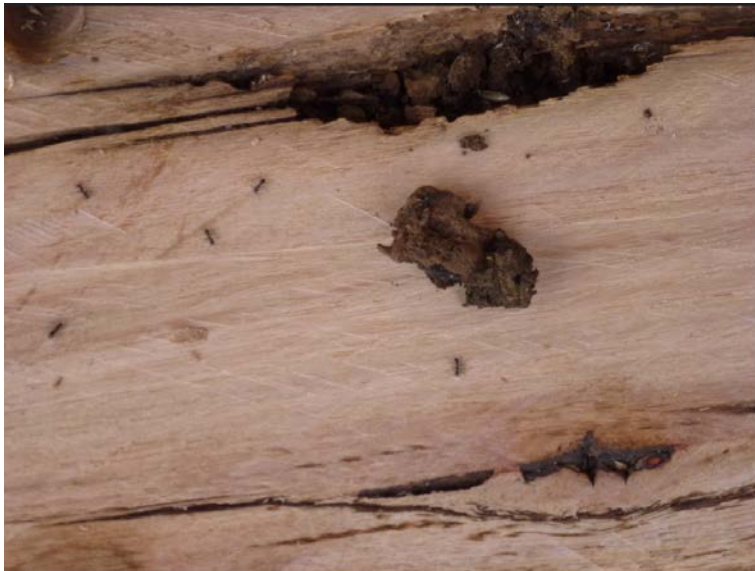
Figure 9: Pole 4 cavity and termite infestation

The pole's outside diameter at the structural failure zone was 250 millimetres with a 200 millimetre central cavity. The outer material thickness of the failure zone averaged 25 millimetres (ranging between 10 millimetres to 40 millimetres). Sections of the outer material thickness at the failure zone also appeared to be affected by timber decay.

- Pole 4 shows clear signs of decay and was significantly hollowed, with the hollowing extending well above the top of the stakes/steel reinforcement (possibly by more than 2 metres)

- Pole 4 was infested with termites above its base (with active termites found to be infecting the remaining upper section of the pole), below which the remaining pole butt was found to be damp

Figure 9 shows the Pole 4 cavity and the termites found during testing.
