P3 High Street Terang Electrical Incident

17 March 2018

Technical investigation report

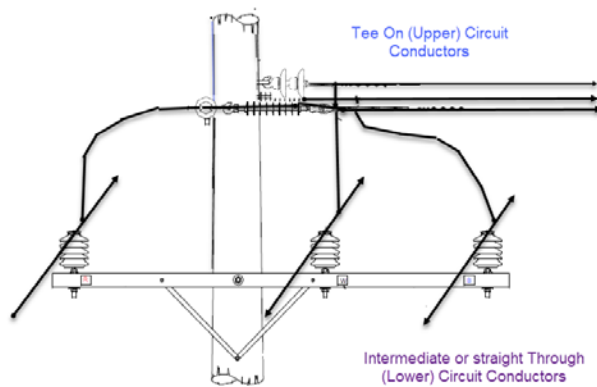
Figure 3: upper and lower P3 22kV circuit layouts

Figure 1 and Figure 2 show aerial views of the incident location of the Terang-Cobden Road fire and the extent of the damage (respectively). Figure 3 shows a diagram of P3 and the arrangement of its upper and lower circuits, which are both 22kV. P3 also carries the Terang to Warrnambool No.2 66kV line in parallel from a crossarm at the top of P3, however there is ample clearance between the lower 22kV and the higher 66kV conductors and there was no evidence to indicate the 66kV line in any way contributed to, or was involved in the incident. This is not shown on the diagram and does not otherwise factor in the investigation.

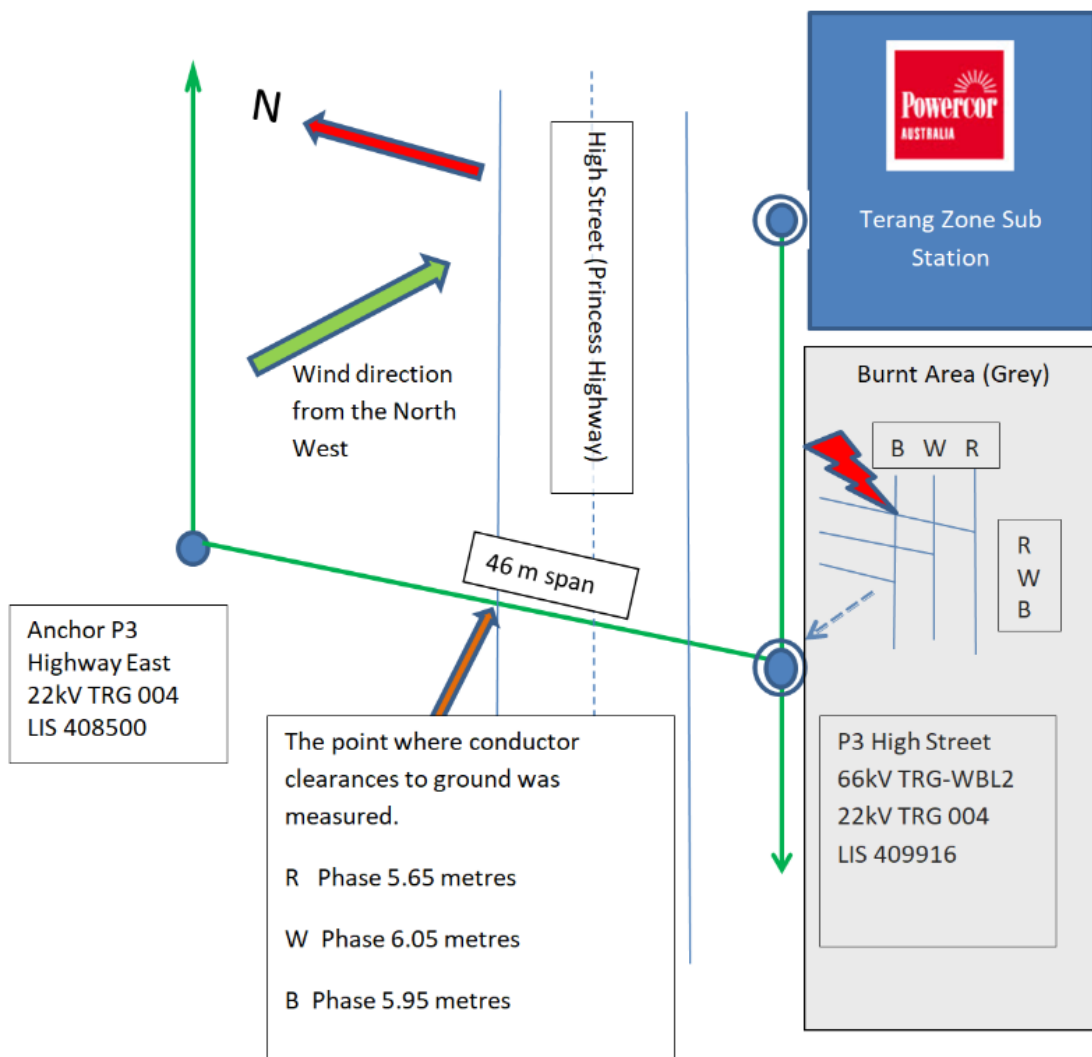
Figure 7: site plan post-event

- prevailing wind direction
- burnt area directly beneath P3 (in grey)
- location of the conductor clash relative to TRG ZSS and High Street (Princess Highway)
- location of ground clearance measurements and the distance measured between the ground and the conductor span crossing High Street prior to the removal of the damaged conductors and the start of restoration work.

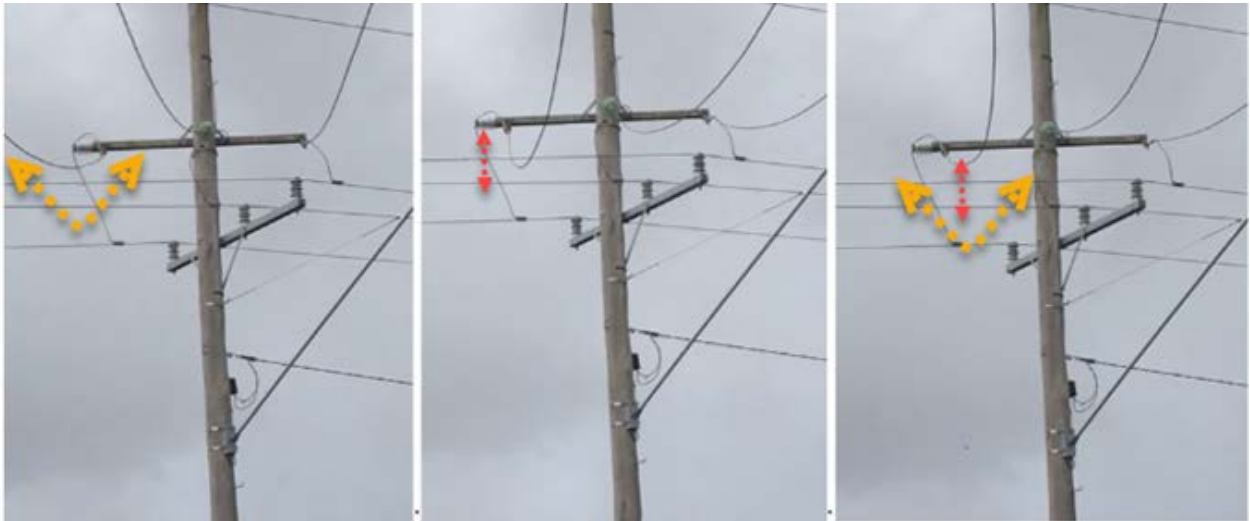
Figure 8: video stills showing the range of conductor movement (horizontal and vertical)

- possible range of movement of the conductors due to gusting winds (up to 96 kilometres per hour recorded at the Warrnambool Weather Station at 11:15 AEST, and 76 kilometres per hour recorded at the Mortlake Weather Station at 11:28 AEST)
- changes in clearance between the upper and lower conductors.

Figure 8 shows a series of stills from the video. In the stills, the yellow arrows indicate horizontal movement (swing) and the red arrows indicate vertical movement. The movement is caused by gusting winds that cause the conductors to move vertically and horizontally at the same time, with the possible range of movement being directly proportional to the amount of sag in the conductor (the greater the sag, the greater the movement).

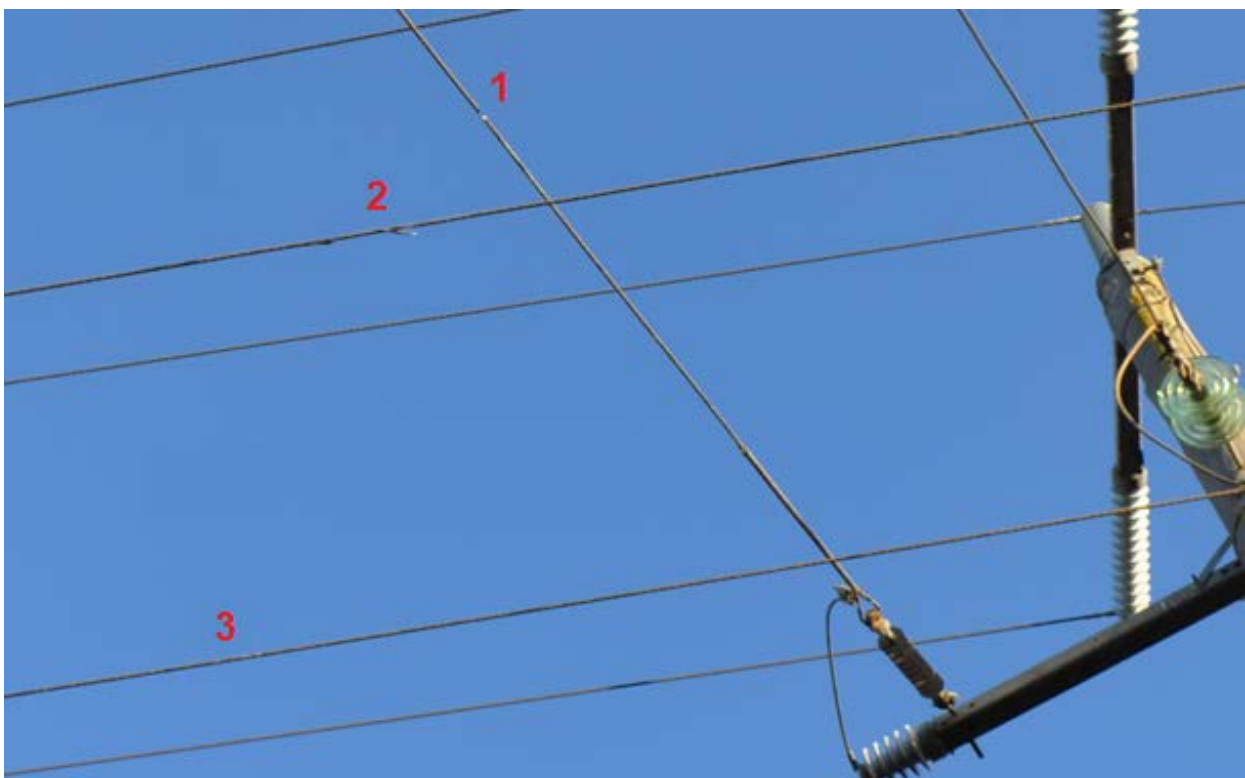
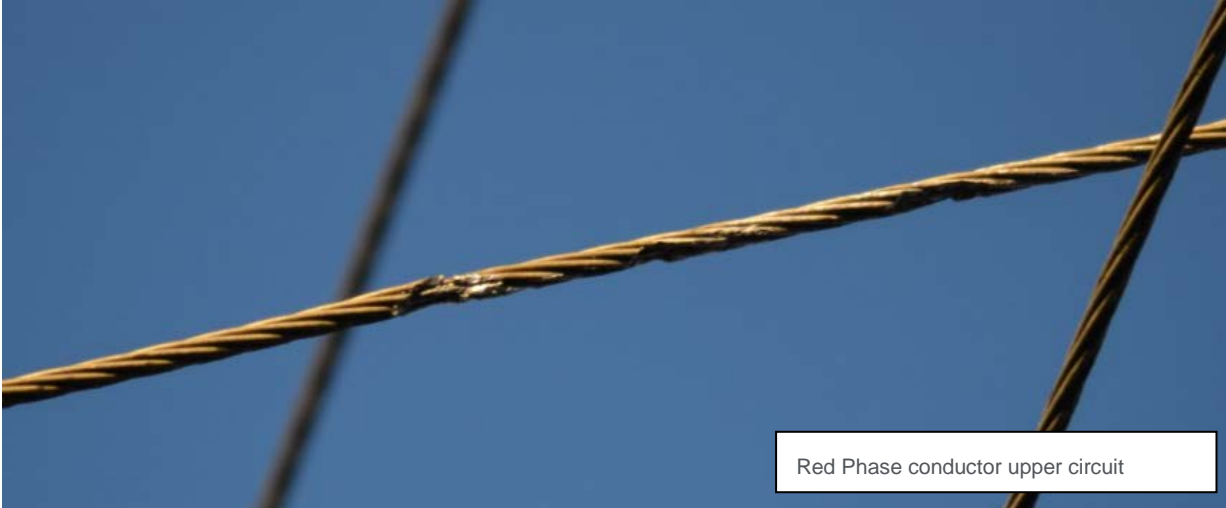
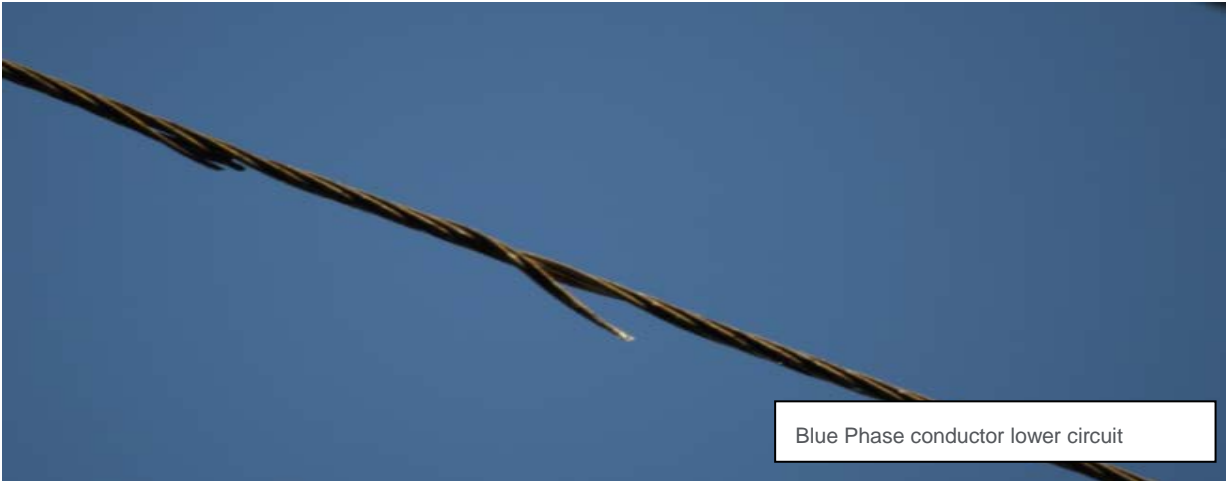
Figure 9: P3 22kV conductor clash damage (position 1, 2 and 3)

Figure 9 shows a series of pictures of the P3 22kV conductor clash damage taken by ESV's enforcement officer on 18 March 2018 (at approximately 17:40 AEST).

White Phase conductor lower circuit (pit marks)

- there was arcing damage to the:
 - upper circuit Red Phase conductor
 - lower circuit Blue Phase and White Phase conductors
- the lower circuit White Phase conductor featured arcing damage likely to have been caused by the arcing of all three phases (see Figure 13 and the three-phase TRG 004 events 2 and 3 for more information; it is also likely that the Blue and Red Phase arcing event created another arc that was blown towards the White Phase conductor, resulting in the two three-phase events)
- damage was limited to the conductors on P3's north-east side.

- upper circuit Red Phase conductor showing localised damage to a 250 millimetre section
- lower circuit Blue Phase conductor showing damage to a longer, 510 millimetre section, which can be explained by the extent of the Red Phase conductor's horizontal movement and the multiple contact points.

Each conductor comprises multiple strands and strand sections were missing from both. This indicates either melting or breakage of the strands due to the effect of arcing from the short-circuit events.

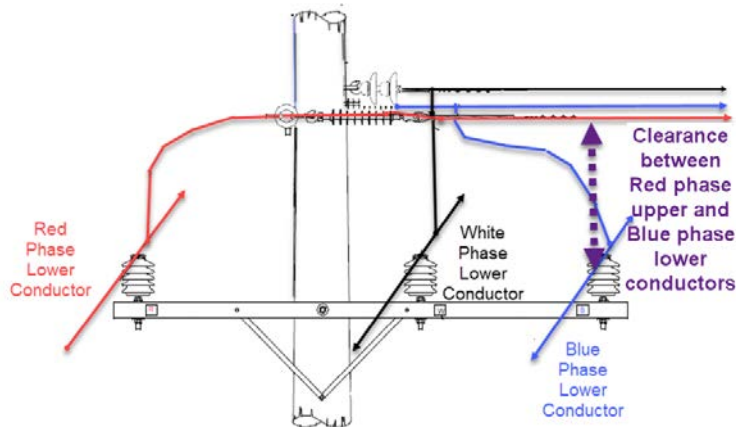
Figure 10: clearances between the upper and lower P3 22kV conductors

Figure 10 shows the layout of the upper and lower P3 22kV conductors, and identifies the Red, White (shown in black) and Blue Phase conductors. It also shows the reduced clearances between the Red Phase upper and Blue Phase lower conductors.

The phase-to-phase clearances measured by Powercor Australia Limited between the upper and lower 22kV conductors (ranging from 210 millimetres¹⁴ to 810 millimetres before repair) were all less than the 900 millimetre phase-to-phase clearance specified by the:

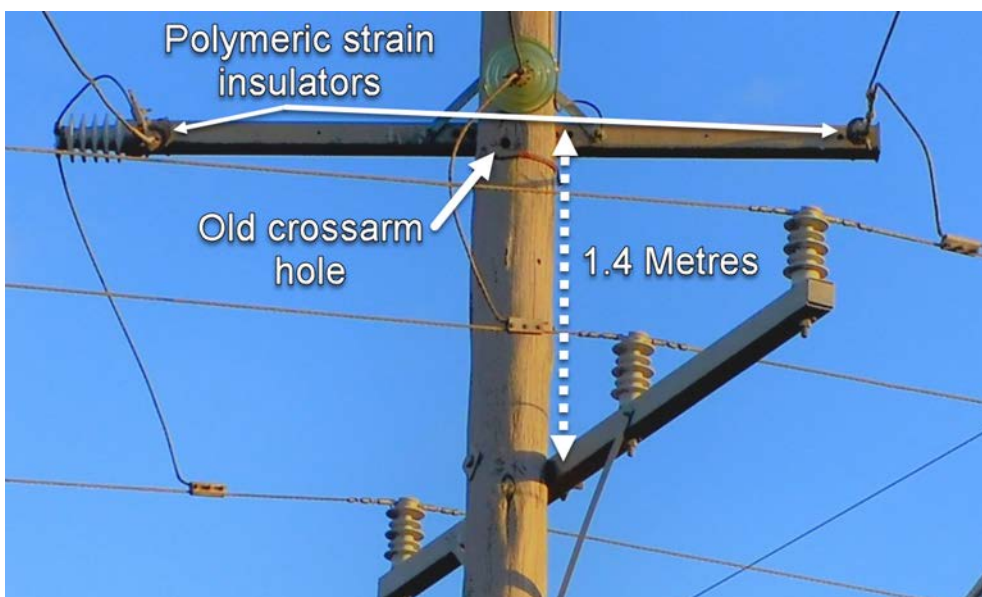
Figure 11: existing crossarm condition

Figure 11 shows the existing P3 22kV crossarms and their condition. From the figure it can be observed that:

- the upper crossarm has been replaced (the date of replacement cannot be verified)
- an old crossarm hole suggests the current upper crossarm has been moved higher up the pole, increasing the clearance between the upper and lower conductors¹²
- the distance between crossarms is approximately 1.4 metres
- two glass insulator discs were left attached to the centre phase upper circuit.

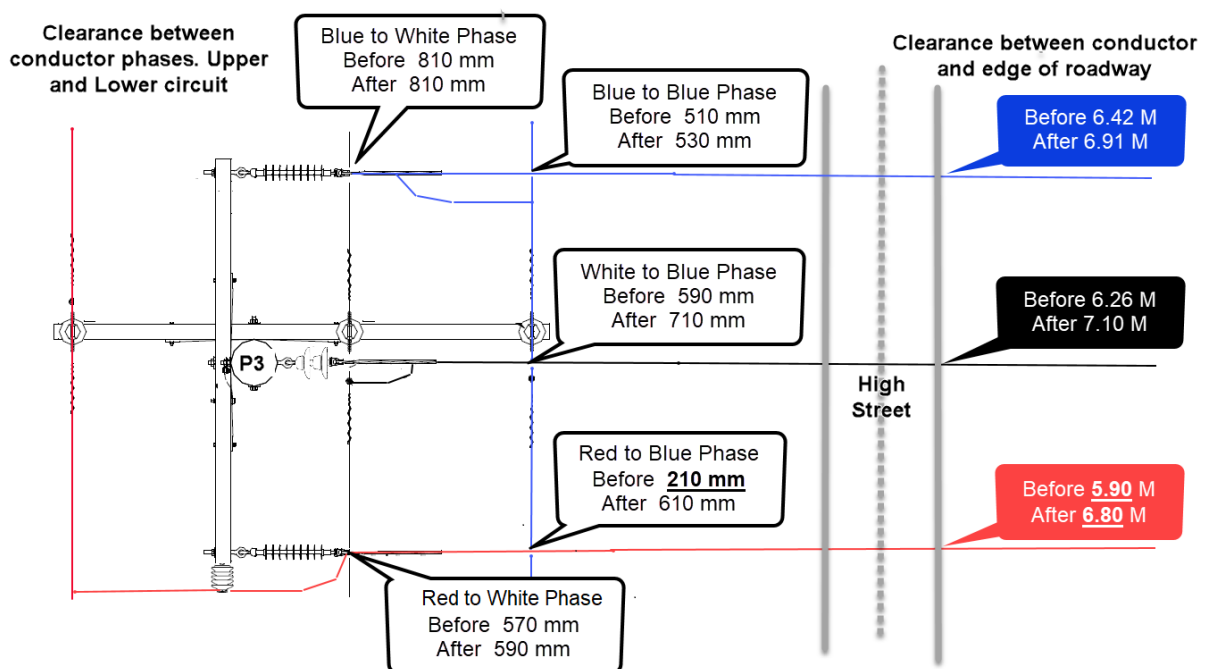
Figure 12: conductor clearances recorded on 19 March 2018 before and after repair

Figure 12 shows a diagram (the original of which was provided by Powercor Australia Limited¹³) that details the conductor clearances recorded on 19 March 2018 before and after repairs. The completed repairs were not constructed to the relevant standards.

- The conductor-to-road/ground clearances measured by Powercor Australia Limited ranged from 5,900 millimetres to 6,420 millimetres before repair. The Overhead Line Design Standard AS/NZS 7000:2016 and the Powercor Australia Limited Technical Standard (DC111) specify a minimum clearance of 6900 millimetres.

Following repairs, the conductor-to-road clearance of one conductor did not meet this standard.

On 19 March 2018, Powercor Australia Limited crews completed repairs that included:

- replacing the damaged conductor sections
- straightening Anchor P3.
