Garvoc Fire (The Sisters) 17 March 2018

Technical investigation report

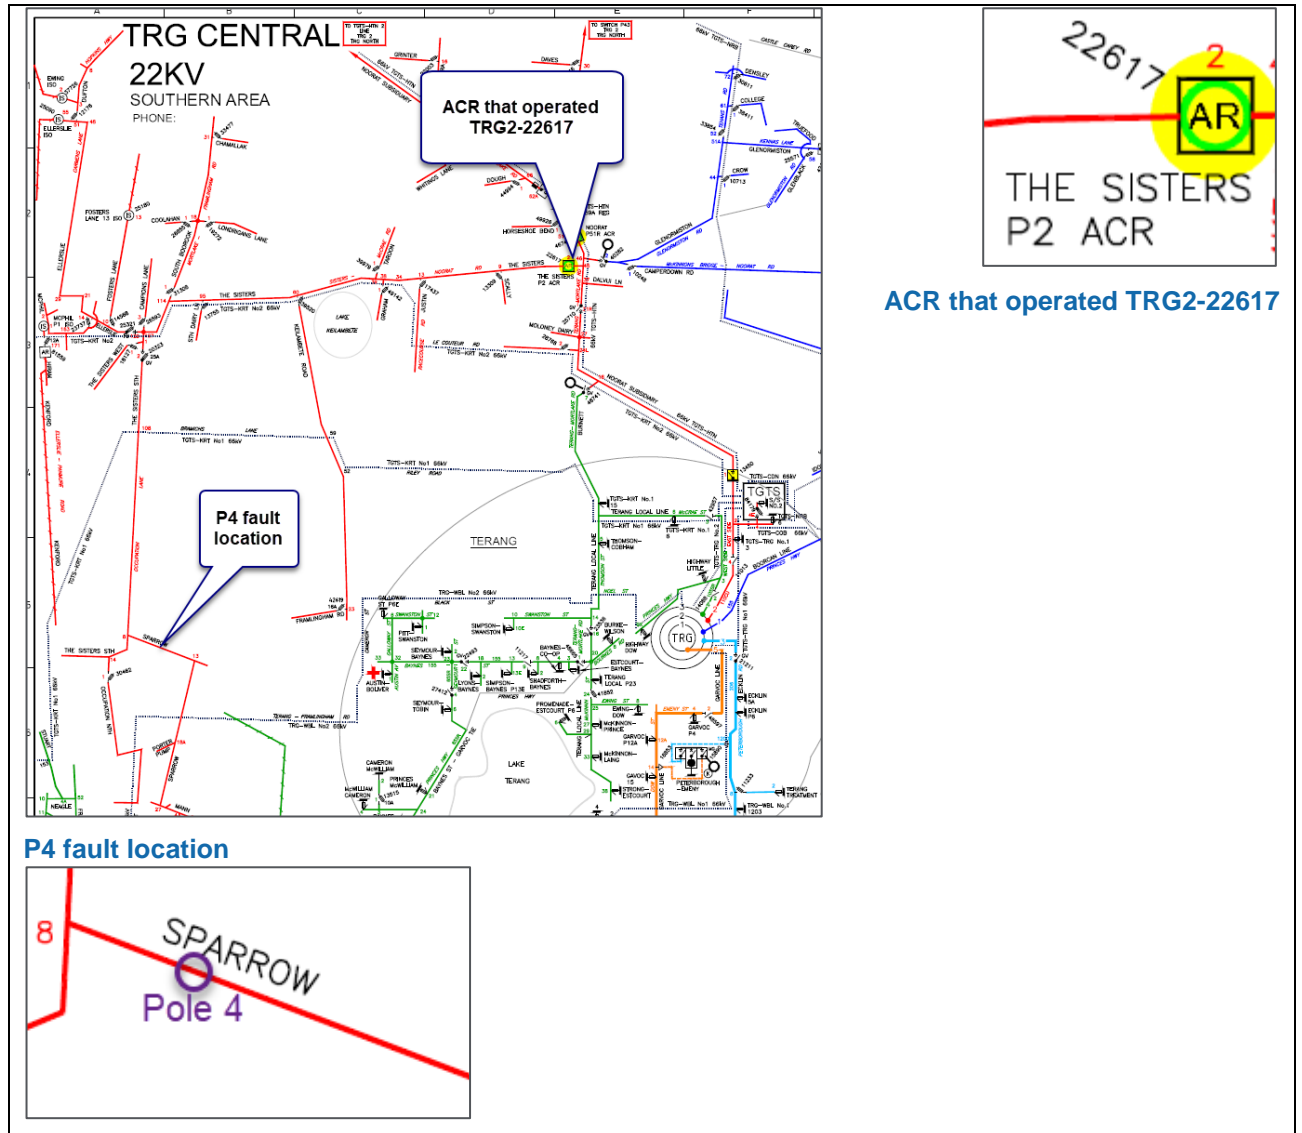
Figure 5: the TRG Central 22kV electrical network diagram and incident location

Figure 5 shows a section of the TRG Central 22kV electrical network diagram and the:

- TRG 002 feeder (in red)
- location of the ACR that operated TRG2-22617 (The Sisters P2 ACR)
- Pole 4 (P4) fault location.

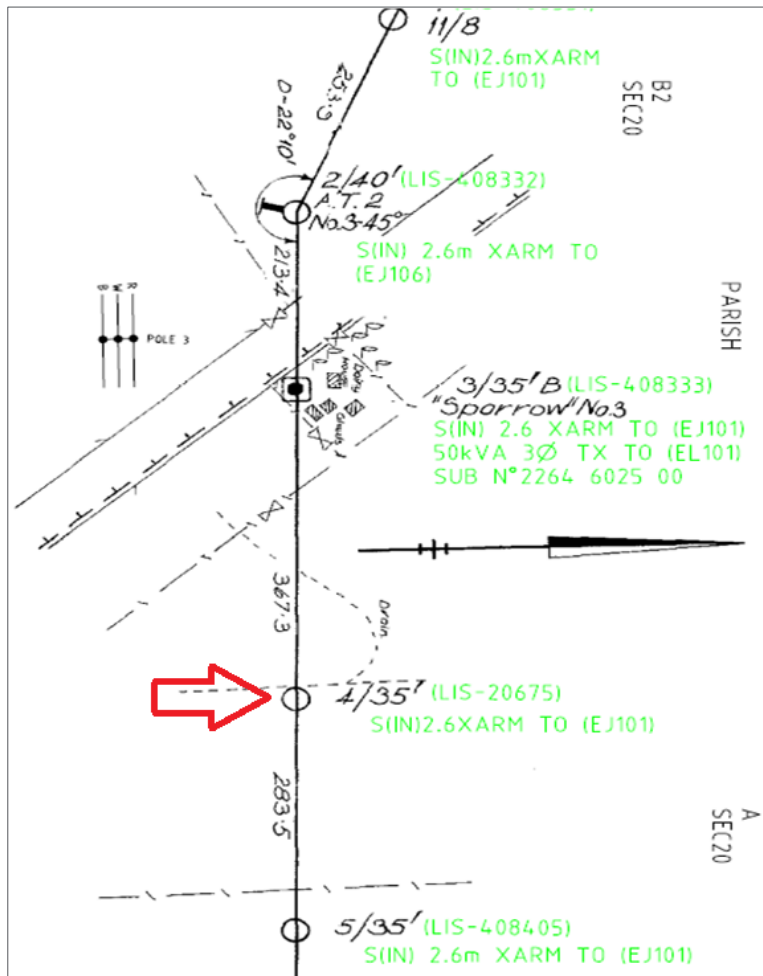
Figure 6: Pole 4 site plan and construction standard detail

Figure 6 shows a section of the detailed route plan identifying the location of Pole 4 (in red) and a reference to its construction standard.
