P3 High Street Terang Electrical Incident

17 March 2018

Technical investigation report

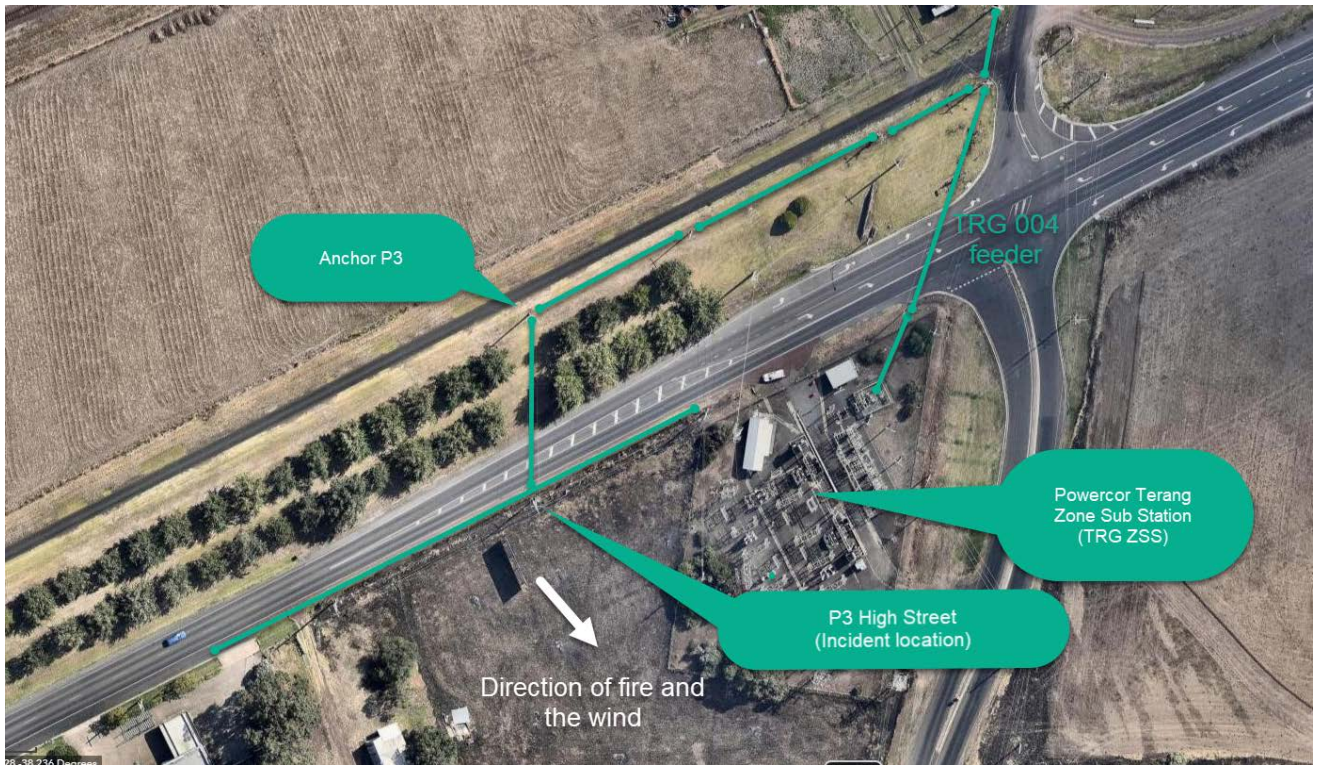
Figure 1: the Terang-Cobden Road fire ignition incident location

Figure 1 and Figure 2 show aerial views of the incident location of the Terang-Cobden Road fire and the extent of the damage (respectively). Figure 3 shows a diagram of P3 and the arrangement of its upper and lower circuits, which are both 22kV. P3 also carries the Terang to Warrnambool No.2 66kV line in parallel from a crossarm at the top of P3, however there is ample clearance between the lower 22kV and the higher 66kV conductors and there was no evidence to indicate the 66kV line in any way contributed to, or was involved in the incident. This is not shown on the diagram and does not otherwise factor in the investigation.

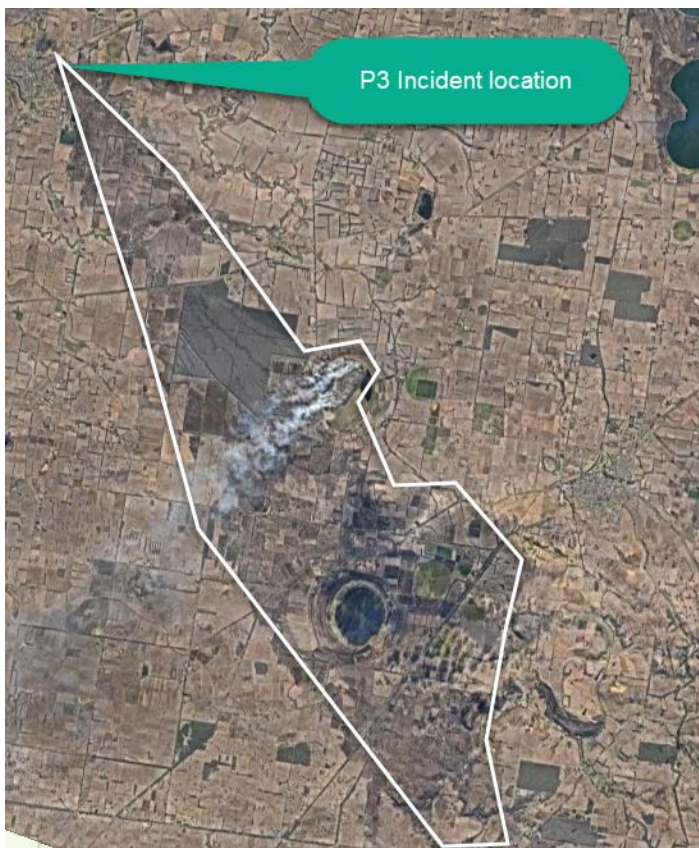
Figure 2: the extent of the Terang-Cobden Road fire (burnt land)

On 17 March 2018, at approximately 20:49 Australian Eastern Standard Time (AEST), a high wind event passing through Victoria's South West Region caused a fault on the electrical network and a fire in the Terang area that resulted in the destruction of eighteen homes and forty-five sheds. There were no fatalities or serious injuries.

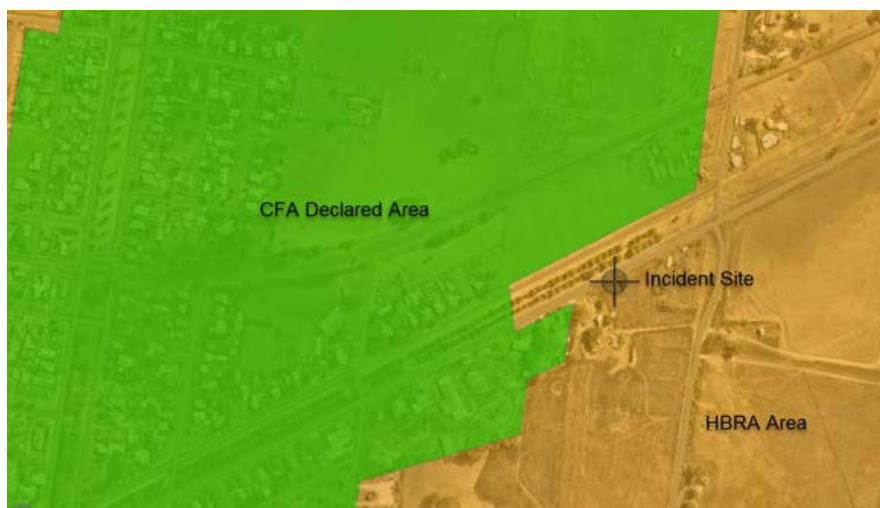
Figure 4: GIS incident site area map

Figure 4 shows a Graphical Information System (GIS) area map of the incident site in relation to the CFA declared Low Bushfire Risk Area (in green) and the HBRA area (in amber).

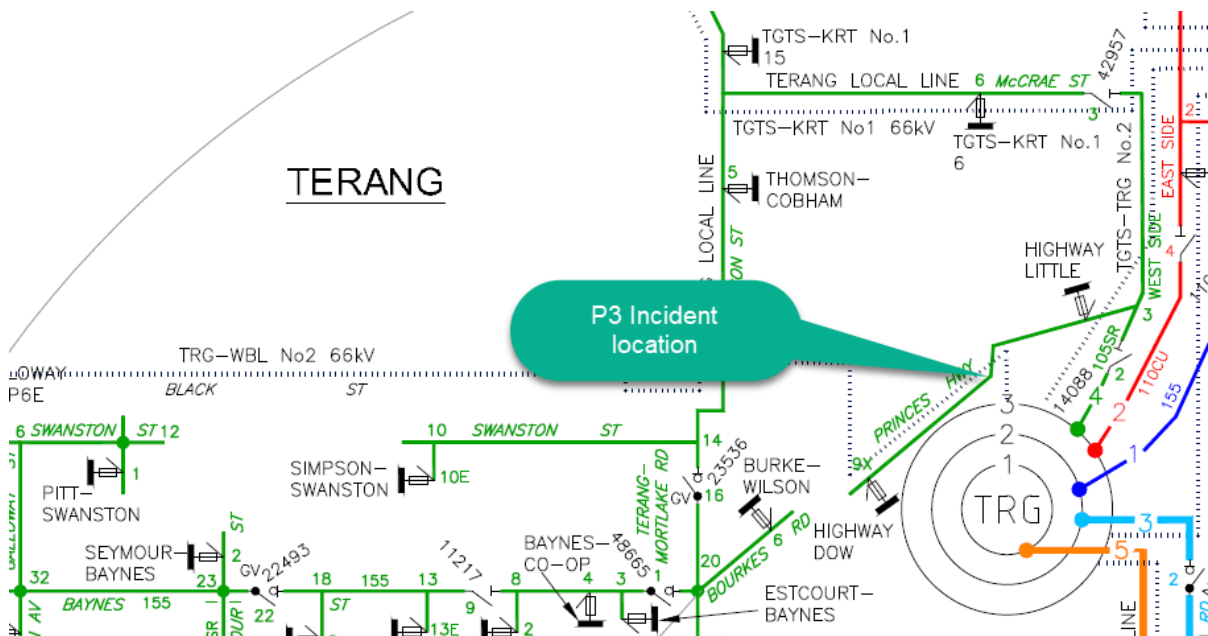
Figure 5: the TRG Central 22kV electrical system diagram and incident location

Figure 5 shows a section of the TRG Central 22kV electrical network diagram and the:

- network assets in the Terang area
- TRG 004 feeder (in green)
- incident location.

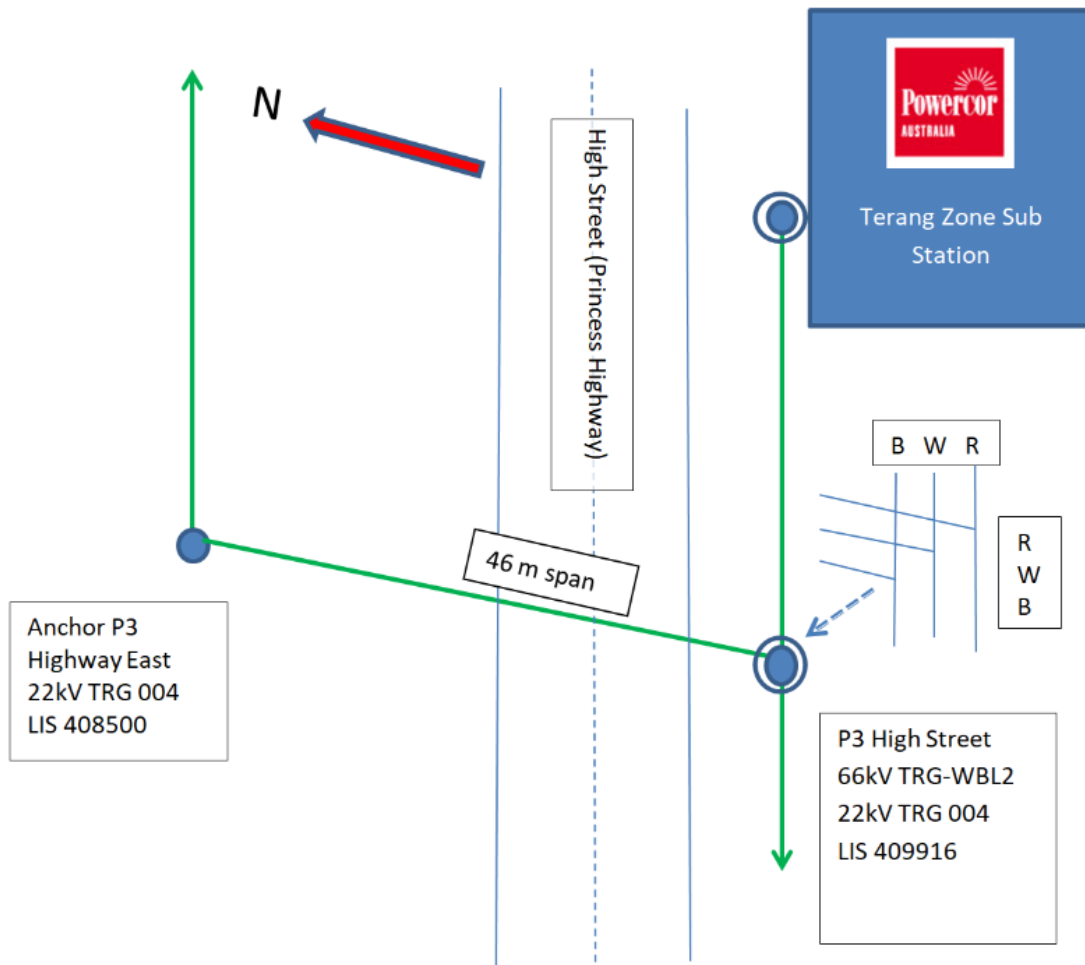
Figure 6: site plan pre-event

Figure 6 shows a plan of the incident location prior to the incident that includes the:
