# SAFETY PERFORMANCE REPORT ON VICTORIAN ELECTRICITY NETWORKS 2014

JULY 2015

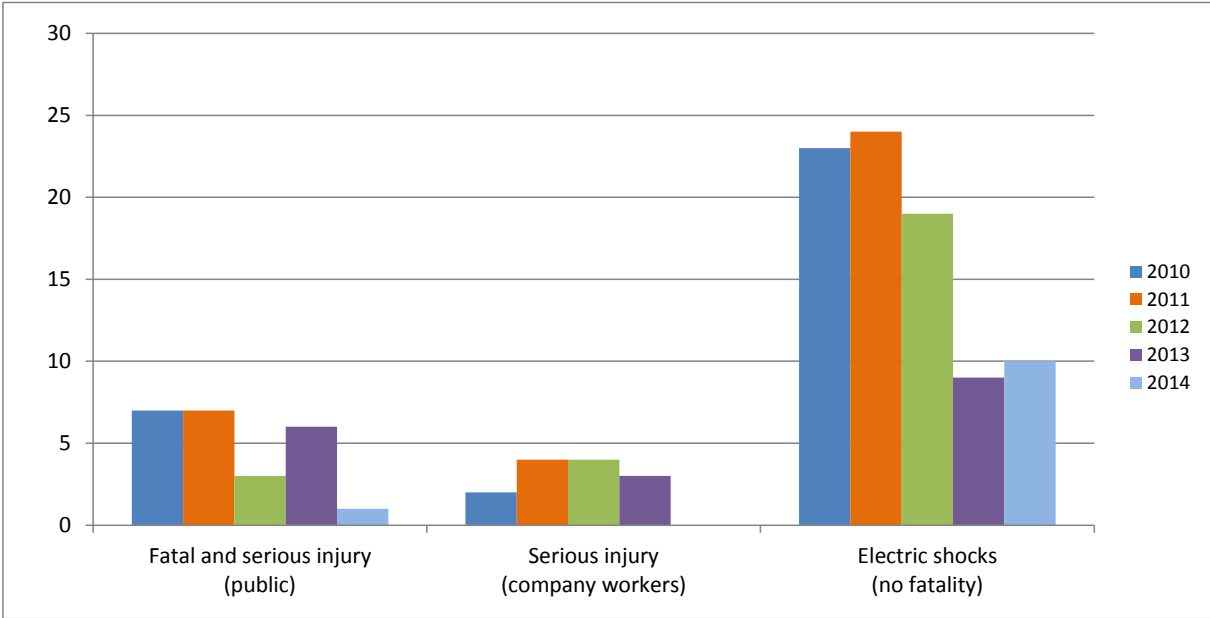
Figure 1: Electrical incidents involving distribution network assets

Given the low levels of incidents reported, it is difficult to be conclusive about trends in the data. That said, electrical shocks without fatality have more than halved over the last five years, serious injuries to distribution company workers and contractors is at least stable, and fatal and serious injuries to members of the public are not increasing. While these trends are positive, efforts need to continue to reduce these further.

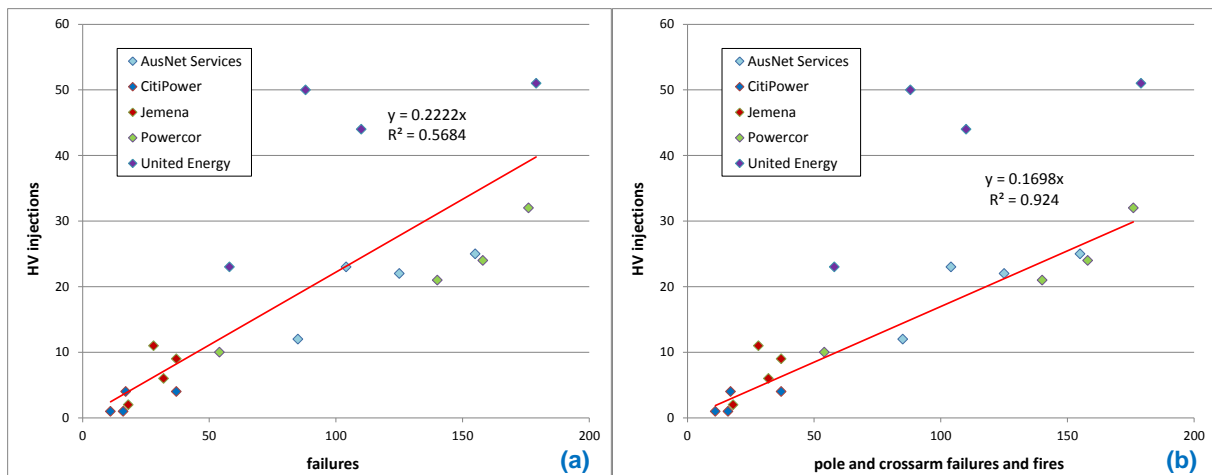
Figure 10: Relationship between HV injections and pole and crossarm failures (a) all distribution companies, (b) all except United Energy

Figure 10 shows the relationship between HV injections and all pole and crossarm failure and fire events (excluding pole-top fires that do not cause vegetation fires). Excluding the United Energy data from the analysis yields a higher correlation of 0.924 between the variables. While this indicates a relationship between these variables, it does not imply a causal link. It does, however, indicate an area of further analysis to better understand the mechanisms leading to HV injections. This, in turn, would allow identification of improved management practices.

The high levels of correlation achieved when the United Energy data is excluded indicate that there is a different mechanism causing HV injections in the United Energy network (or at least a more dominant mechanism). This warrants further investigation with United Energy to better understand the causes of HV injections in its network in order to reduce the risks to the general public from its assets.

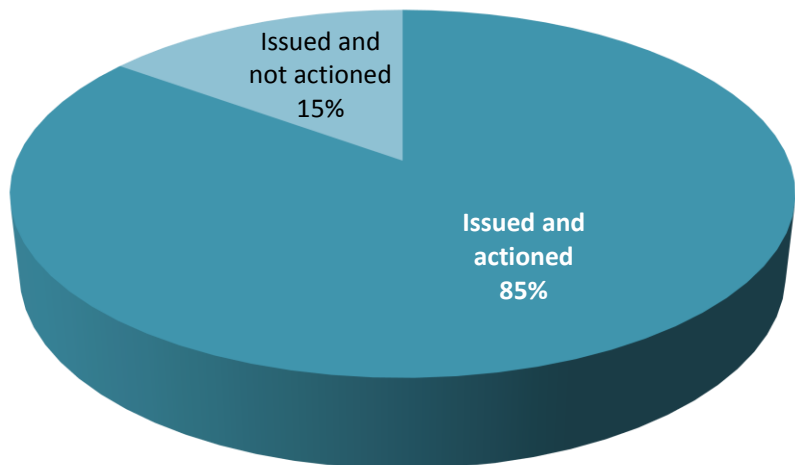
Figure 15: Action status of noncompliant spans within 60-day period – municipal councils

Figure 15 identifies the action status of the noncompliances issued to municipal councils within the 60-day period. Where noncompliance notices were issued, councils typically responded in an appropriate manner, although on occasions this required additional time to rectify issues. Most noncompliances have now been actioned and the relevant vegetation brought into compliance.

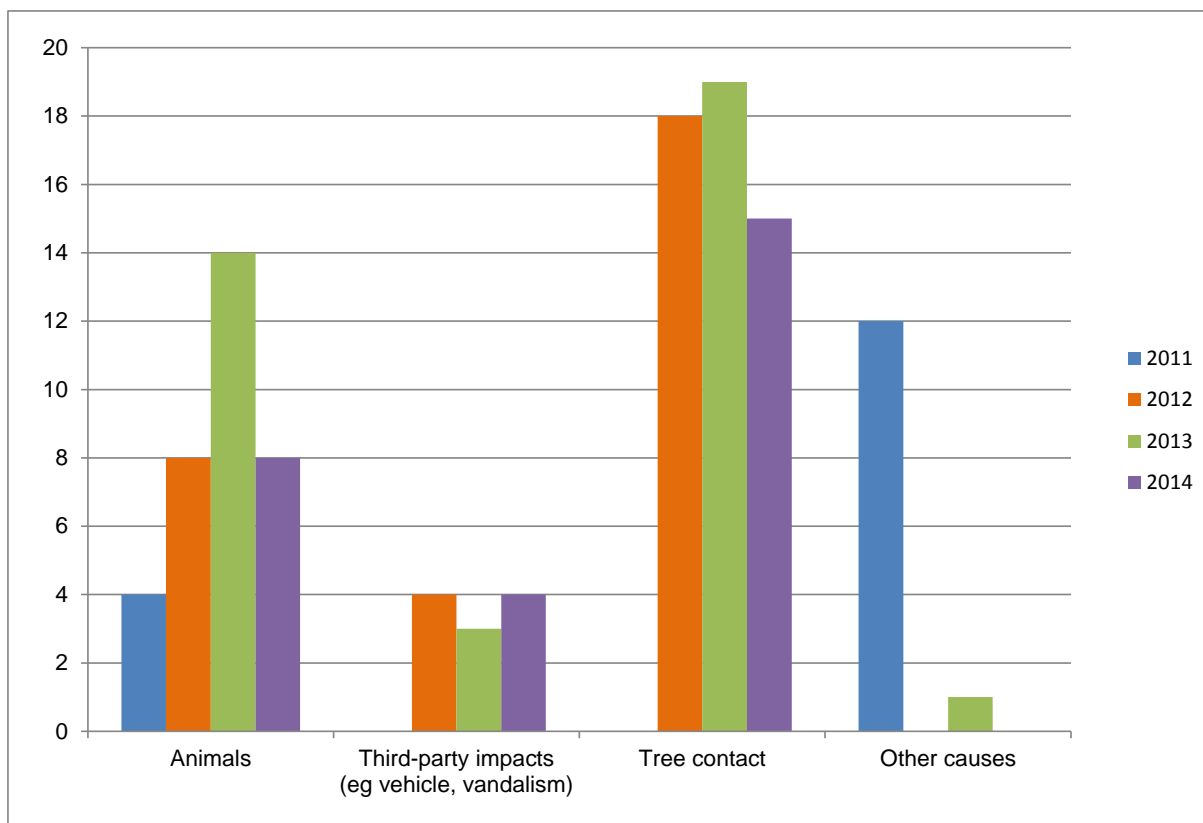
Figure 21: Vegetation fires resulting from contact with assets – AusNet Services

Figure 20 and Figure 21 provide comparisons of the failure causes for asset failure fires and contact event fires respectively. These show upward trends in fires resulting from pole and/or crossarm fires, HV fuses and LV asset failures. These are counterbalanced by downward trends in fires from animal impacts (a short-term reduction after a longer upward trend), tree contact and other contacts. There is also a general stability in fires from pole and/or crossarm failure, oil-filled plant and third-party impacts.

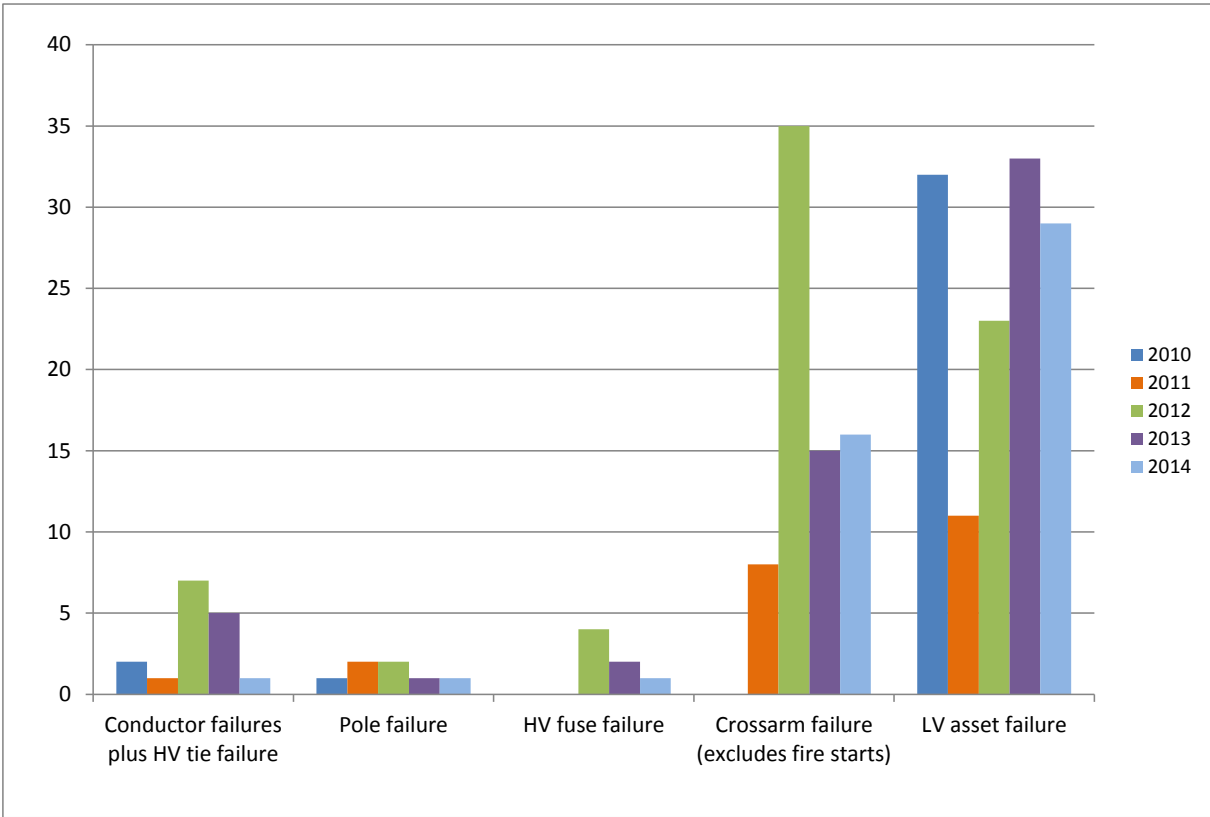
Figure 25: Asset failures by type – CitiPower

In 2014, CitiPower reported a 14 per cent reduction in the total number of asset failures between 2013 and 2014 (Figure 25 and Table 19).

Total asset failures peaked in 2012 and have been reducing since then. This is reflected in reductions in conductor failures and HV fuse failures. Pole failures also appear to be stable at a low level of incidents. This is positive.

There are, however, some areas of concern. Crossarm failures have been increasing over the last five years. This has included a major peak in 2012 that needs to be considered when looking at total asset failures as it tends to mask some negative trends post-2012. This includes the upward trend in LV asset failures, which have more than doubled since 2011 and represented 60 per cent of CitiPower’s asset failures in 2014.

The main area of concern is the increase in LV assets failures since 2011. Such failures can lead to power outages and broken neutrals, both of which pose serious safety risks. ESV recommends that CitiPower investigates the root cause of its LV asset failures and implements programs to reduce the number of failures and reverse the upward trend observed over the last four years.

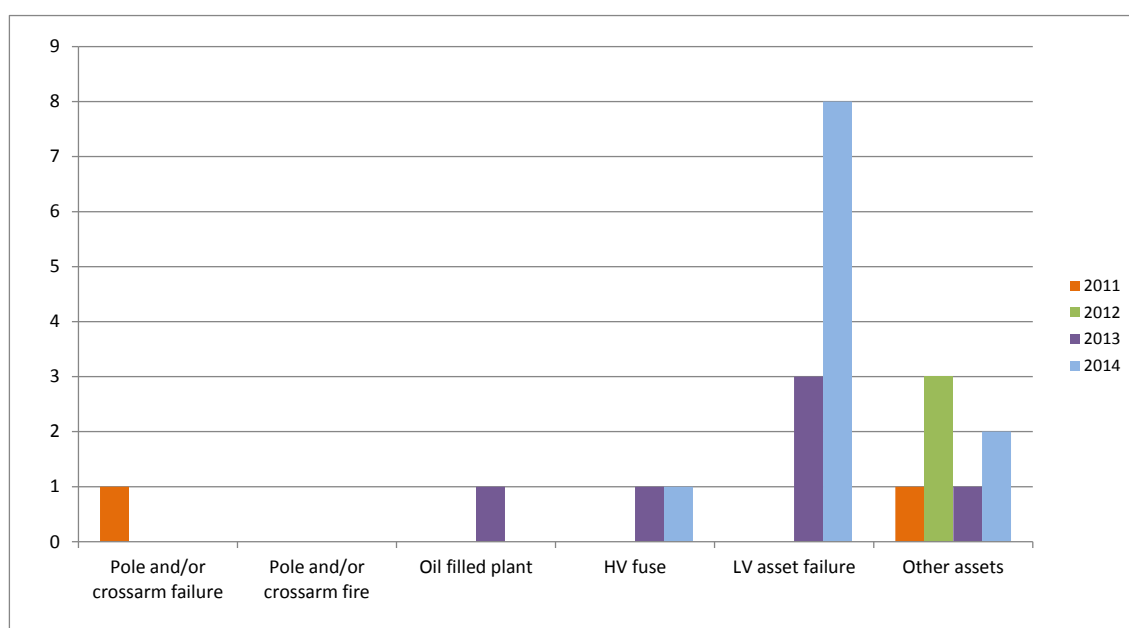
Figure 27: Vegetation fires resulting from asset failures – CitiPower

Unfortunately efforts to reduce contact events have been offset by an increase in vegetation fires resulting from asset failures. This has predominantly been due to the increase in fires associated with LV assets (Figure 27). Failures of LV assets accounted for 67 per cent of all vegetation fires in 2014. CitiPower has not advised ESV of the cause of the increasing LV asset-related fires.

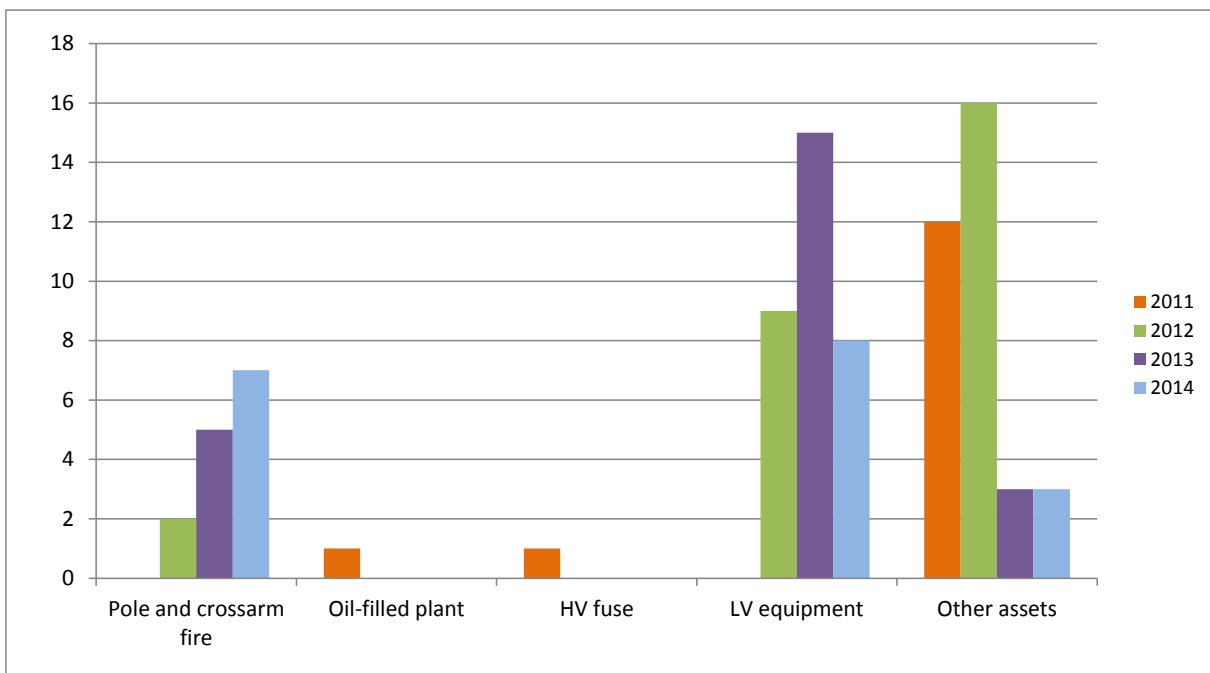
Figure 28: Fires on or in assets – CitiPower

There has been an increase in pole and crossarm fires over the last four years (Figure 28). There were no pole and crossarm fires in 2011 and now they account for 39 per cent of all fires — second only to LV equipment fires.

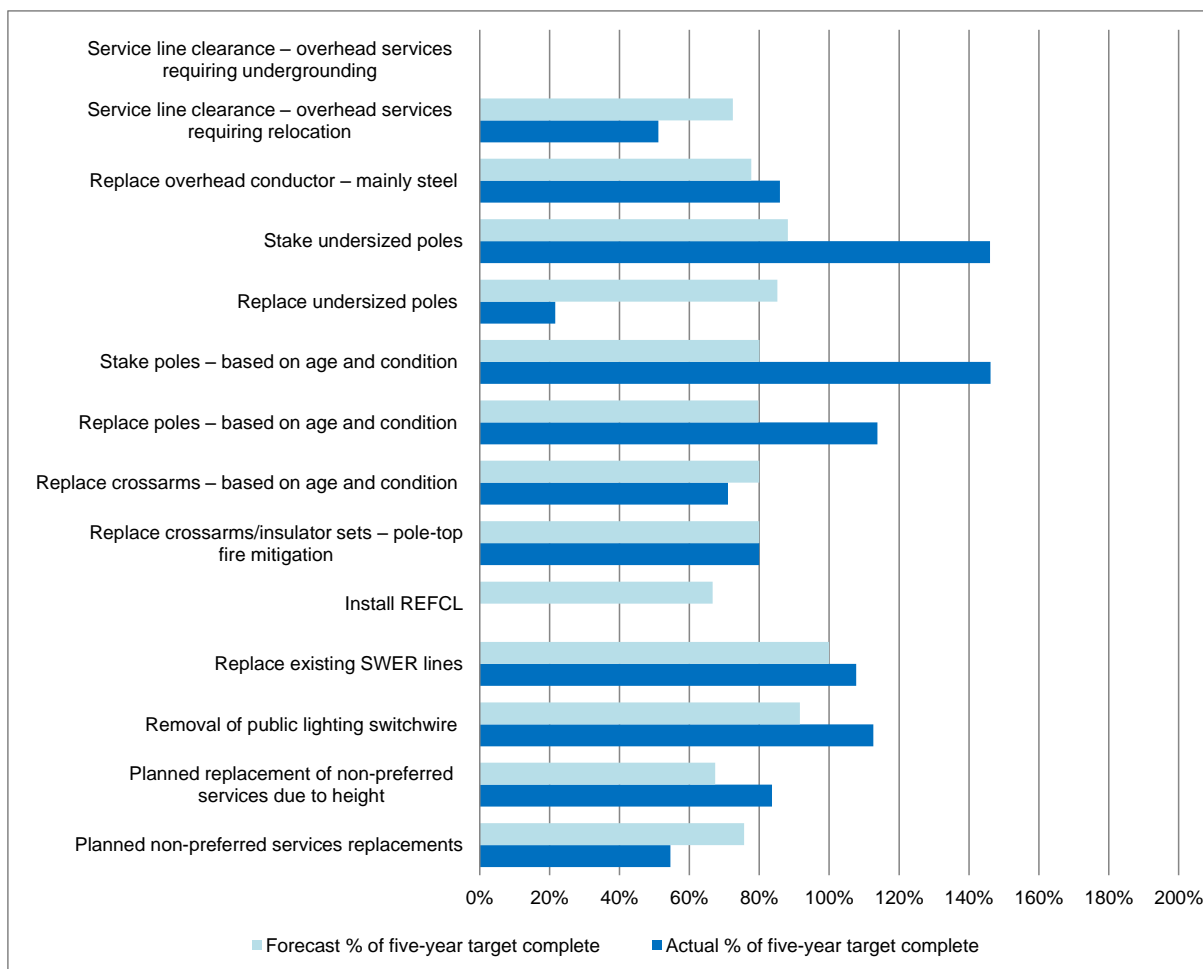
Figure 29: Status of Jemena's safety programs

Jemena reports on 14 safety programs to ESV. Performance against target is shown graphically in Figure 29. Specific data on the status of these safety programs are provided in Table 23.

Progress on six of the programs is ahead of Jemena's forecast:

- replace overhead conductor – mainly steel
- stake undersized poles
- stake poles – based on age and condition
- replace poles – based on age and condition
- removal of public lighting switch wire
- planned replacement of non-preferred services due to height.

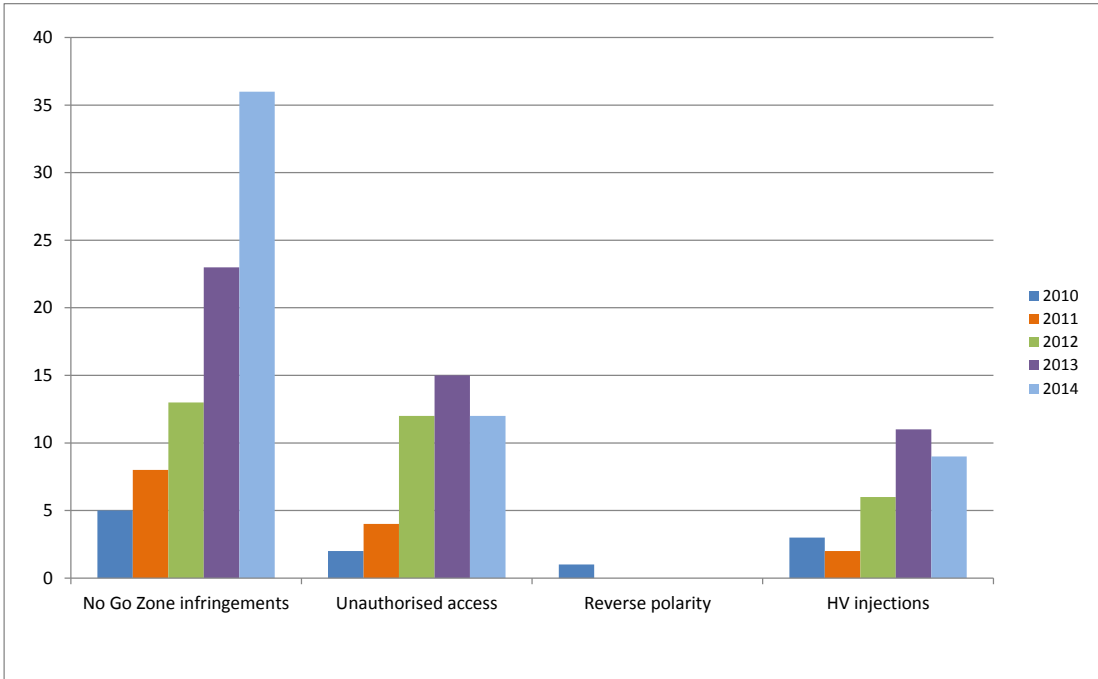
Figure 30: Safety incidents involving the public – Jemena

Figure 30 graphically shows the incidents involving the public interacting with Jemena's assets. The data underpinning this figure are provided in Table 27.

Unauthorised access and HV injections had also been increasing up to 2013, but had experienced declines in 2014. Jemena should maintain its current controls and seek opportunities for improvement to prevent the upward trend reoccurring.

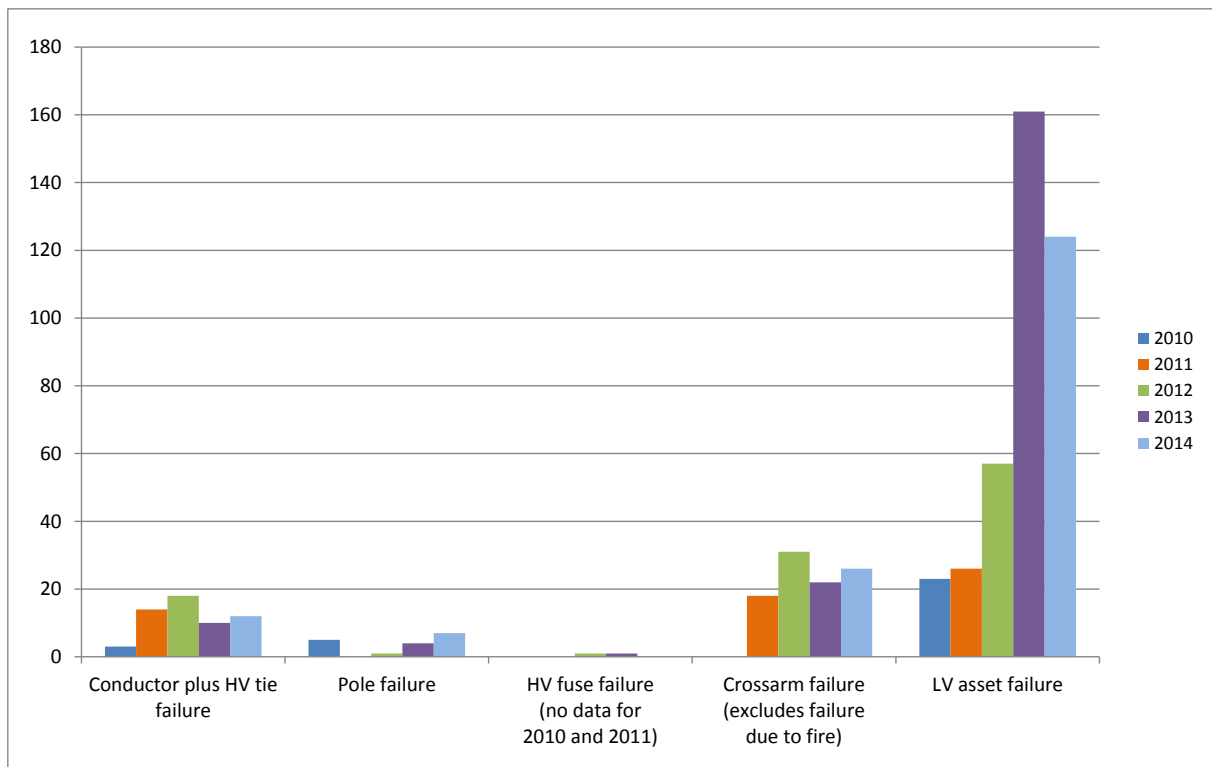
Figure 32: Asset failures by type – Jemena

In 2014, Jemena reported a reduction in the number of failures of LV assets compared to 2013 (Figure 32 and Table 28). While the total number of asset failures decreased in 2014, there has been an upward trend in total failures over the last five years.

LV assets represented 73 per cent of Jemena’s total asset failures in 2014. While the number of LV asset failures reported in 2014 has reduced from 2013, they remain at a relatively high level (more than double the number in 2012).

Crossarm failures were the next highest contributor at 15 per cent of asset failures. These increased by four in 2014; however, 2013 represented a drop of nine from 2012. Overall, there is no discernible upward or downward trend in the number of crossarm failures.

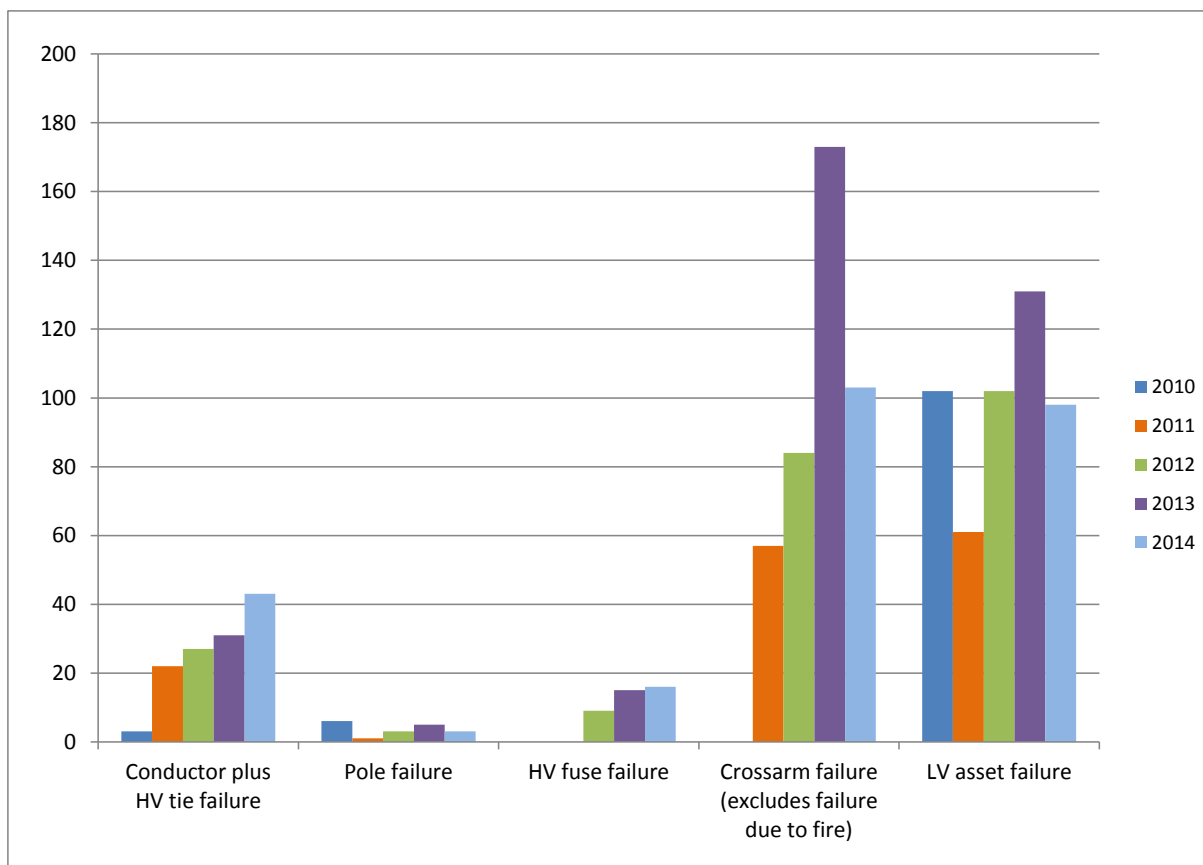
Figure 45: Asset failures by type – United Energy

In 2014 United Energy reported a 23 per cent overall performance improvement in asset failures from 2013 (Figure 45 and Table 45). This is the first reduction in overall failure numbers since 2010. While this reduction is welcome, the evidence of the upward trend reversing will be if numbers continue to reduce in future years.

<sup>38</sup> It should be noted that the decrease in the numbers of crossarm failure in 2014 could be due to United Energy's reclassification of failure events for 2014. This would make it appear that United Energy's performance has improved in 2014. Further discussion on this issue is provided in Section H.2.2.
