# Safety performance report on Victorian electricity networks

November 2021

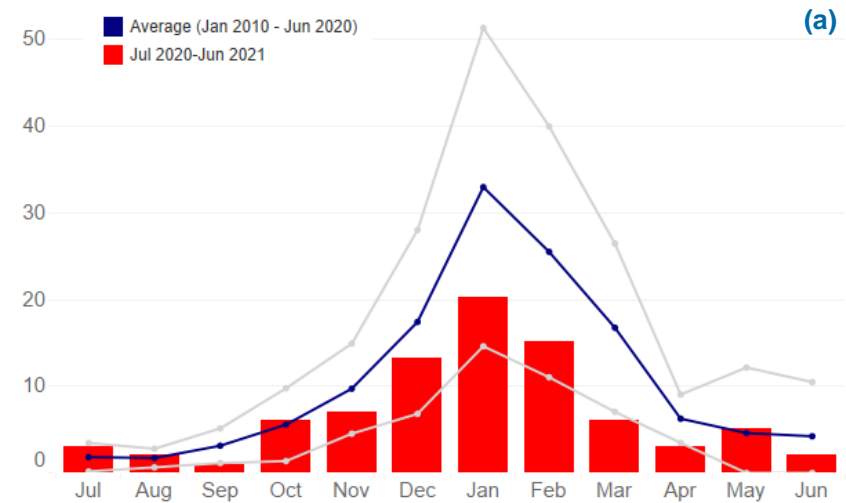
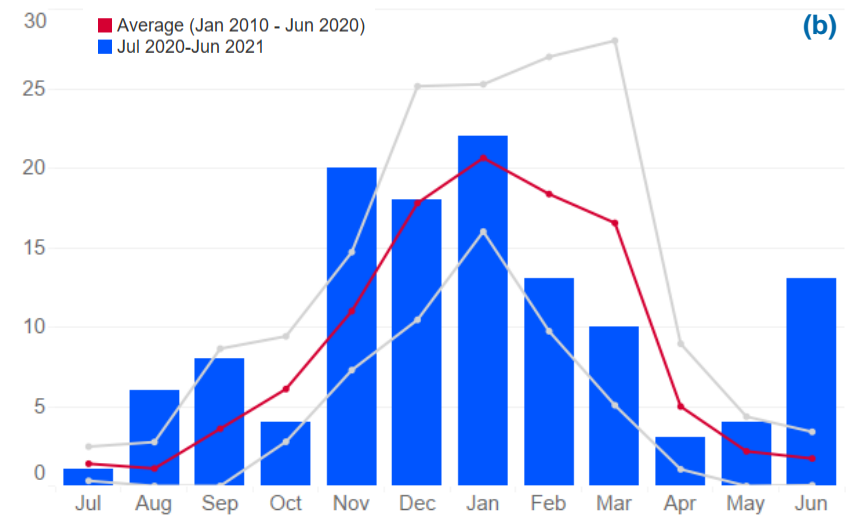
**Figure 2 Ground fire incidents due to (a) asset failures and (b) contact events**

The grey line is one standard deviation above and below the average

The averages and bounds in Figure 2 show a clear seasonal trend in ground fires due to both asset failures and contact events. Throughout most of the year, there are similar numbers of fires from asset and contact events; however, there is a more pronounced peak in asset-related ground fires in January and February.

The numbers of asset-related ground fires (red bars in Figure 2a) were within one standard deviation of the 2010-2020 average for most of the year. The exceptions were September, March and April, which had fewer fires than expected. The number of fires across bushfire season (November to April) was below the long-term average for each month.

Figure 2b shows that the numbers of contact-related fires were well in excess of the historic numbers in August, November and June. The numbers of fires across most of the bushfire season were in line with historic expectations, with the exception of November.

The outlier in Figure 2b is the peak in June that is well above the normal band of expected fires. Of the 13 contact-related fires in June 2021, tree contact was the cause of five fires on 9 June (all on the United Energy network) and four fires on 10 June (three on the United Energy network and one on the AusNet Services network). These incidents coincided with a major storm event that swept across Victoria, with much of the damage in the Dandenong Ranges and Bass Coast. At its peak, approximately 300,000 customers had lost supply due to wind gusts of 100-140 km per hour, which brought down trees and powerlines.

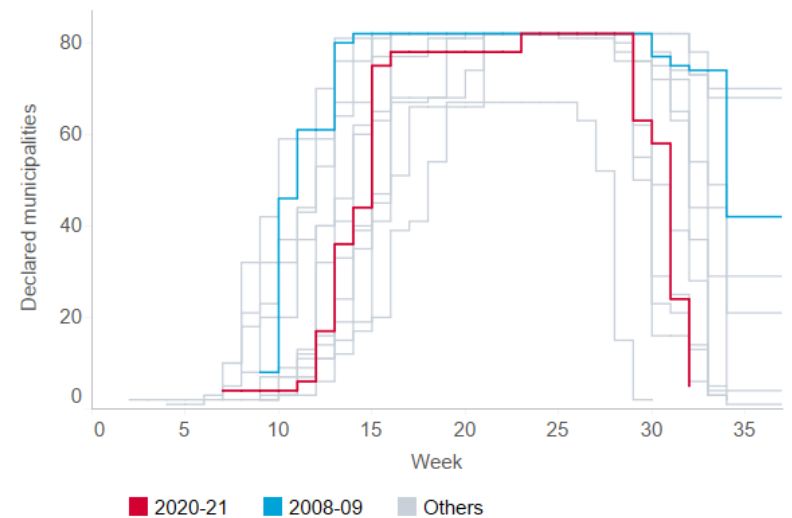
Figure 4 Summary of CFA fire declarations from 2008 to 2021

The first declarations for this year's season started later than last year, but still weeks earlier than most previous seasons (Figure 4). Despite these initial declarations, the escalation of declarations was much slower than for the 2008-09 bushfire season (Black Saturday). Full declaration was much later this season and was short-lived, with declarations being removed quickly soon after full declaration. The official fire season finished several weeks earlier than previous years.

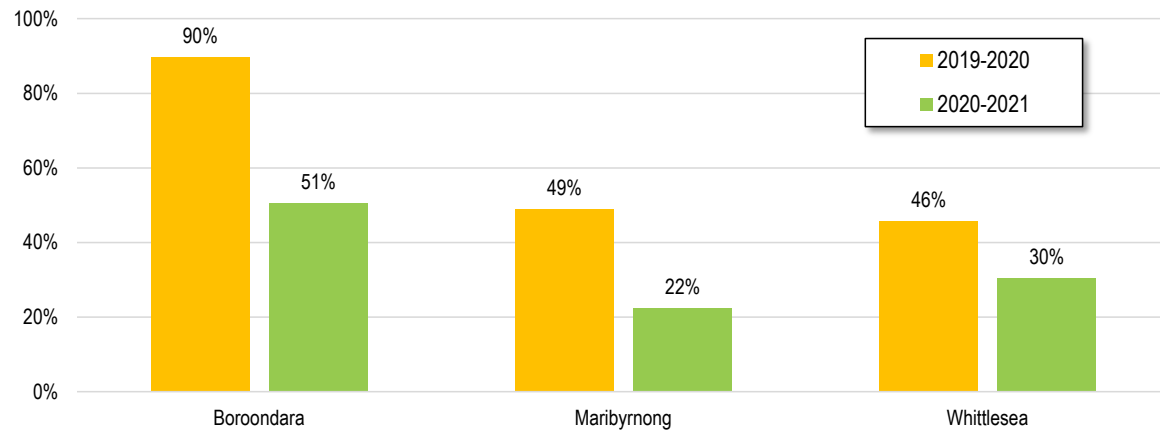
**Figure 12 Performance improvement of three worst-performing councils from 2019-2020**

In 2020-21, ESV revisited the three poorest-performing councils from the 2019-2020 period — the City of Boroondara, the City of Maribyrnong and the Shire of Whittlesea. This was done to ensure they had improved their electric line clearance performance and reduced the electricity safety risks in these municipalities. Failing to demonstrate improved performance would have resulted in strict enforcement action.

It was pleasing to note that each of these councils had responded by showing vastly improved compliance standards; greatly improving electricity safety in these municipalities (Figure 12).

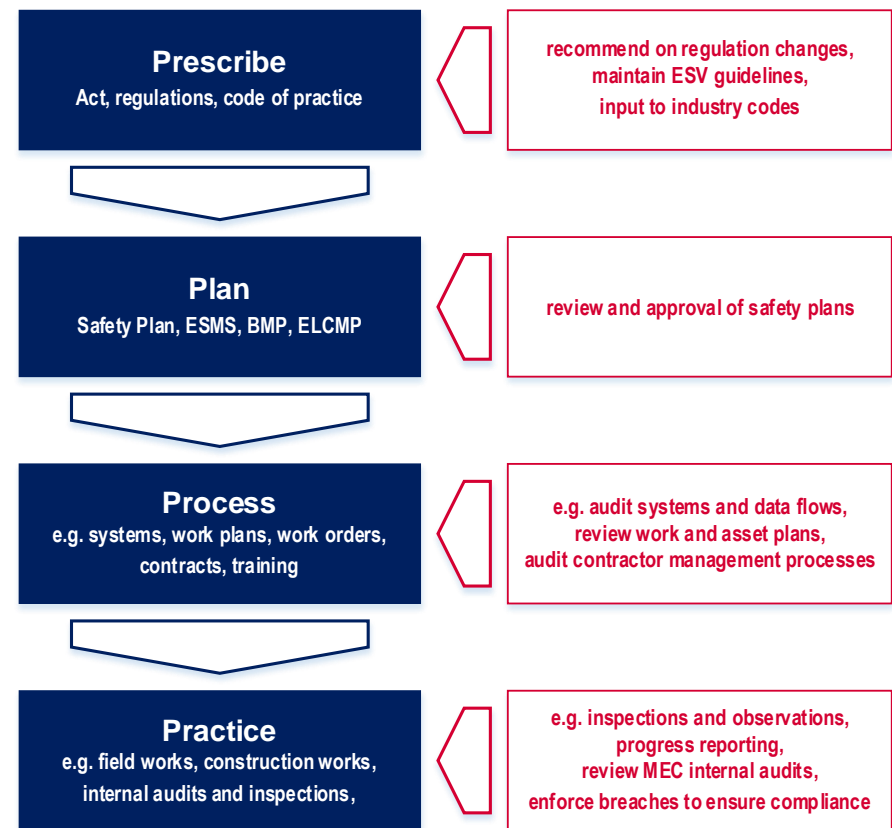
Figure 19 The regulatory hierarchy of controls

ESV undertakes a wide range of functions to ensure safety risks are being appropriately managed by the Victorian transmission and distribution networks. Figure 19 shows an idealised hierarchy of controls, illustrating how the *Electricity Safety Act* and associated regulations flow down through the various plans into processes, and are finally deployed as practices on the ground. The blue boxes designate the levels within the hierarchy and examples of elements at each level.

As regulator, ESV attempts to gain insight into the various levels of the hierarchy to ensure that failures at the top levels don't manifest at systemic issues at the lower levels. Examples of the tools we use to gain insight are shown as the red boxes in Figure 19.

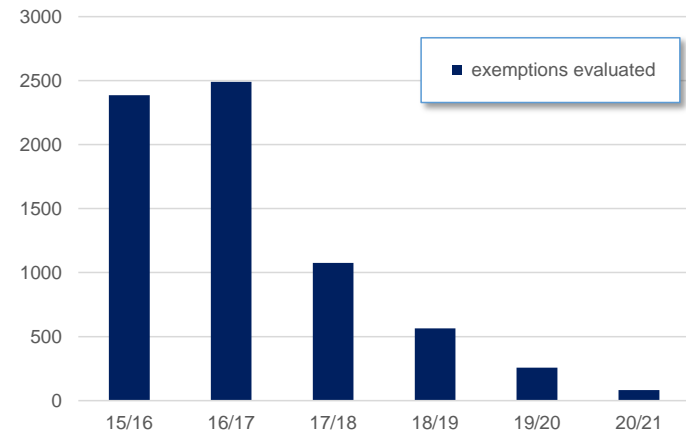
Figure 24 Electric lines on public lands exemptions

The number of such applications has fallen dramatically from its peak in 2016-17 (Figure 24). The bulk of applications received in recent years related to the installation of the National Broadband Network (NBN). Those applications have tapered off significantly now that most of the network backbone has been deployed.

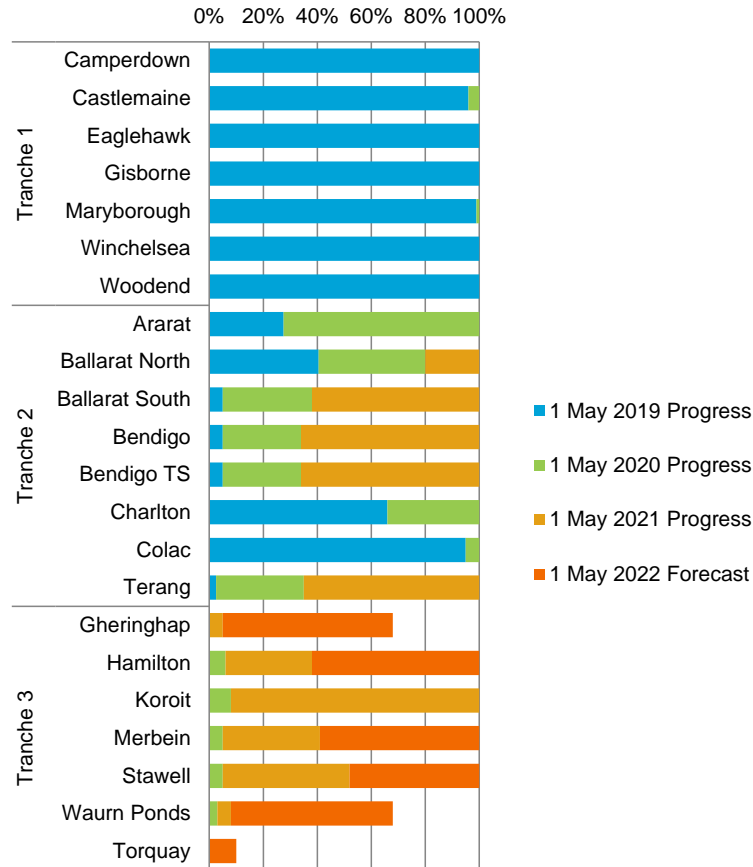
Figure 46 Status of the Powercor REFCL program

Figure 46 shows the progress of the Powercor REFCL installation program at 1 May 2019, 2020 and 2021, and its anticipated progress in the next twelve months.

By 30 June 2021, ESV had accepted sixteen zone substations as compliant.
