# Jemena wood pole management

A review of sustainable wood  
pole safety outcomes

Public report

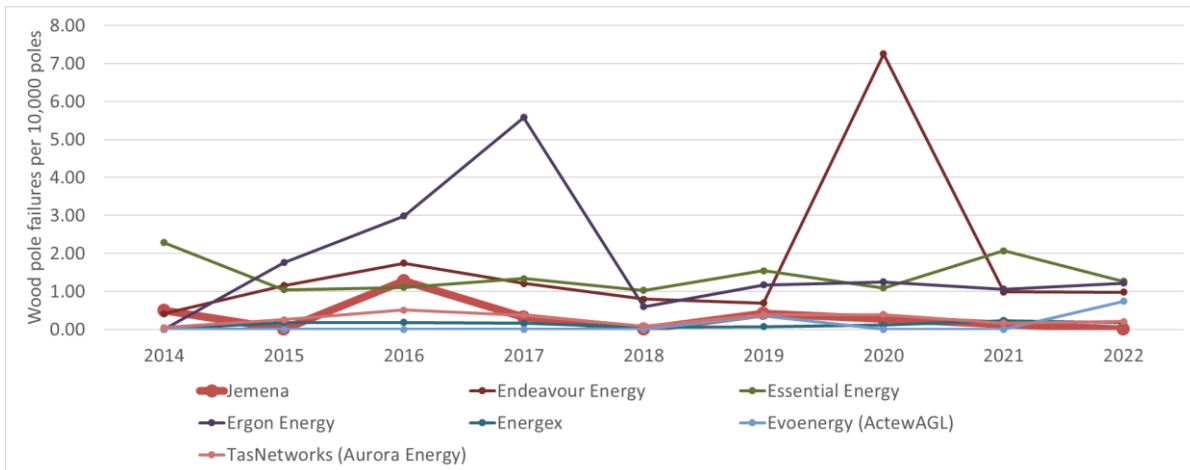
**Figure 4: Comparison of unassisted wood pole failure rate – other Australian DNSPs**

Jemena’s wood pole failure rate also compares favourably with that of the other distribution utilities in the National Electricity Market (NEM), as shown in the diagram below. The average NEM distribution utility unassisted wood pole failure rate over the last five years is 0.98 poles per 10,000. Jemena’s average unassisted wood pole failure rate over the same period is 0.16 poles per 10,000.

Source: Energy Safe analysis of Regulatory Information Notices and Energy Safe quarterly reports<sup>14</sup>

<sup>14</sup> Energy Safe AER RIN data from businesses with comparable failure definitions. Jemena data was obtained from Energy Safe quarterly reports.
